Carvin Cove Dam (~~Inventory Number~~ VA 02301). Roanoke River Basin.
Botetourt County, Virginia. Phase I Inspection Report.

REPORT DOCUMENTATION PAGE		READ INSTRUCTIONS BEFORE COMPLETING FORM
1. REPORT NUMBER VA 02301	2. GOVT ACCESSION NO.	3. RECIPIENT'S CATALOG NUMBER
4. TITLE (and Subtitle) Phase I Inspection Report National Dam Safety Program Carvin Cove Dam Botetourt County		5. TYPE OF REPORT & PERIOD COVERED Final

REVISION NO. 1 TO PHASE I INSPECTION REPORT
NATIONAL DAM SAFETY PROGRAM

CARVIN COVE

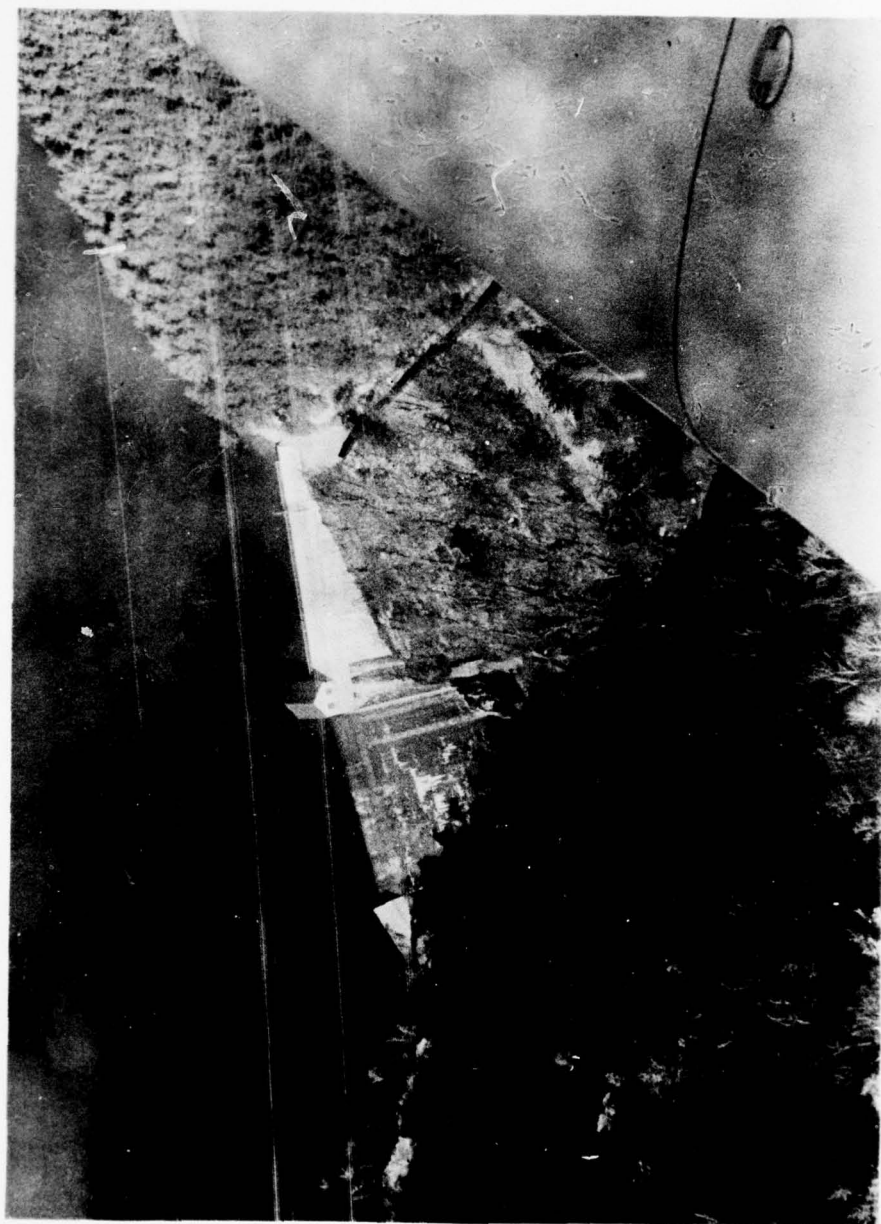
CARVIN COVE DAM - OVERVIEW SHOT

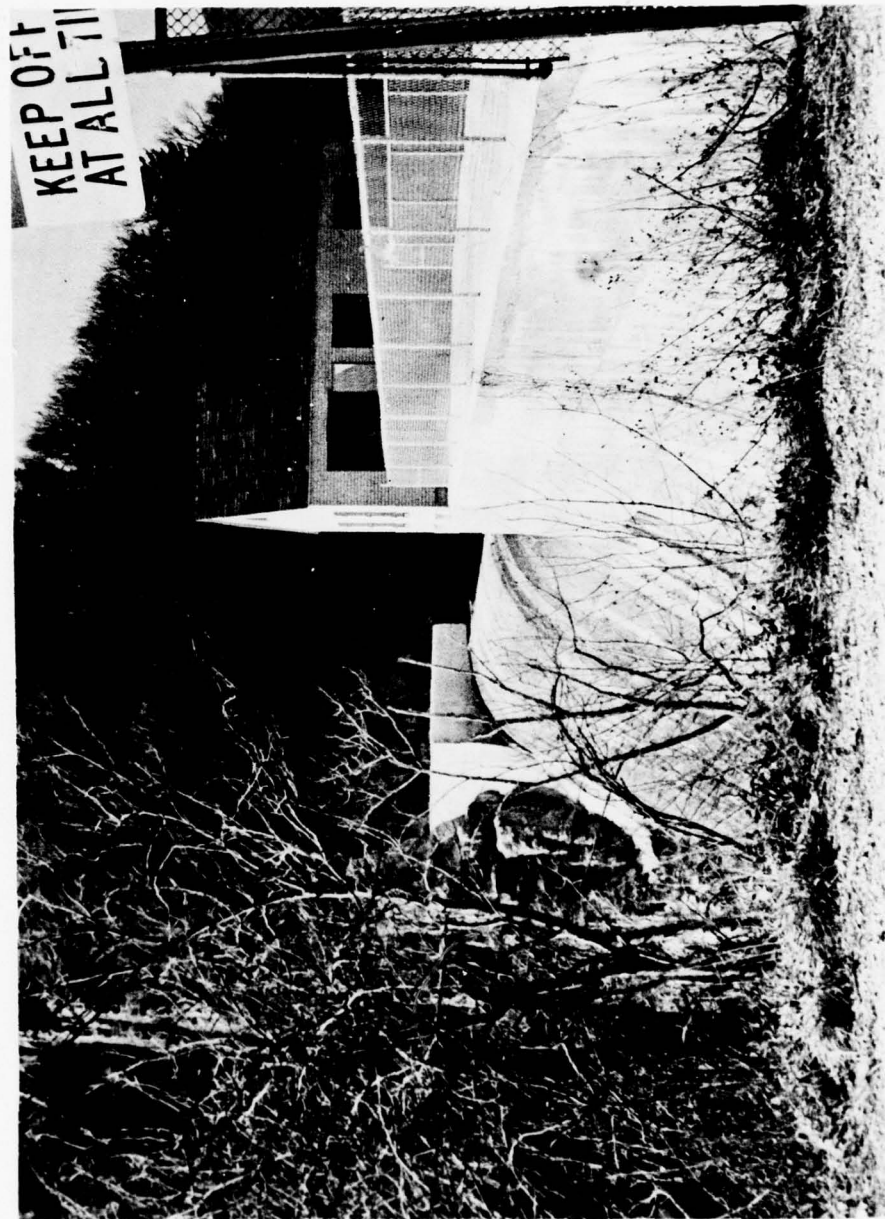
CARVIN COVE DAM - VIEW FROM LEFT
ABUTMENT SHOWING VALVE PIT HOUSE
AND SPILLWAY

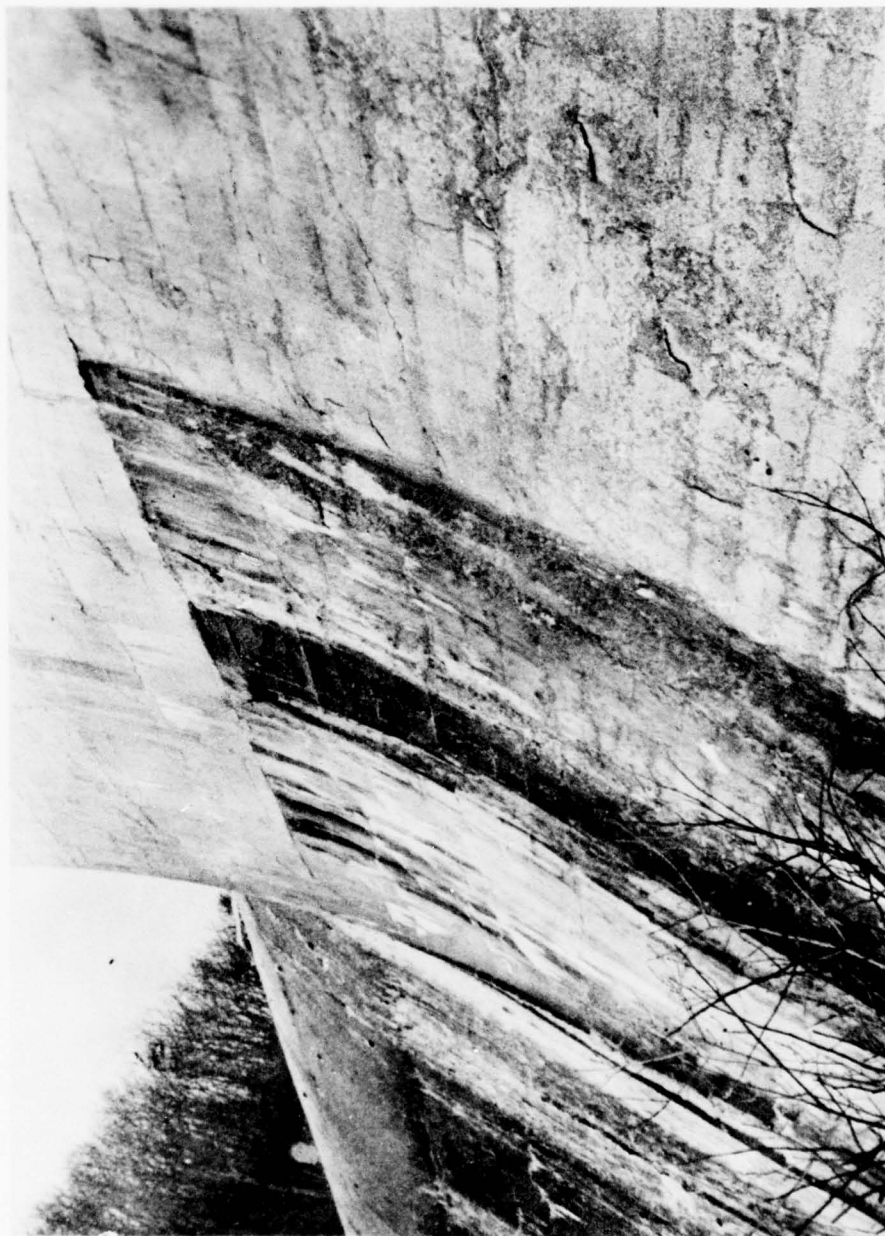
3.2 Evaluation: The visual inspection revealed 5 or 6 through seepage points which occur through the face of the dam approximately 17 feet below elevation 1175. These are located directly in front of the valve pit house, on the downstream face. A rather large seep also occurs in the valve pit nearest the spillway at approximately the same elevation as the seeps on the face of the dam. This is a good indication a plane of seepage exists about 17 feet below the top of the dam underneath the valve pit house. Nothing was observed in the field that required immediate remedial action. Later hydraulic and stability calculations indicated that overtopping was critical. The relatively small amount of surface flaking which has occurred on the face of the dam over the last 50 years indicates the dam has good weathering capabilities. The only remedial surface treatment done to the dam is a grout coat applied to the top and extending 5 feet down either face of the dam. The horizontal cracking on the face of the dam appears to occur along the concrete lift lines. Over a 50 year life cycle, this is not an uncommon occurrence. There is no evidence to indicate the cracks are other than facial. These cracks will promote accelerated weathering of the dam. In addition to the ground seeps observed on the right abutment a wet spot was noted at the dam's left abutment interface at approximately elevation 1167+. No material was observed piping from the wet spot, and in fact flowing water was not observed. All presently observed seeps in the abutments are considered minor in nature, however, they should be observed during weekly inspections to prevent a worsening condition going unobserved.

CARVIN COVE DAM - SEEPS IN DAM
UNDER VALVE PIT HOUSE

7.2.1.2 Ground Seeps: Immediately set up and maintain a regular observation schedule of inspecting the ground seeps to prevent a worsening condition going unobserved.

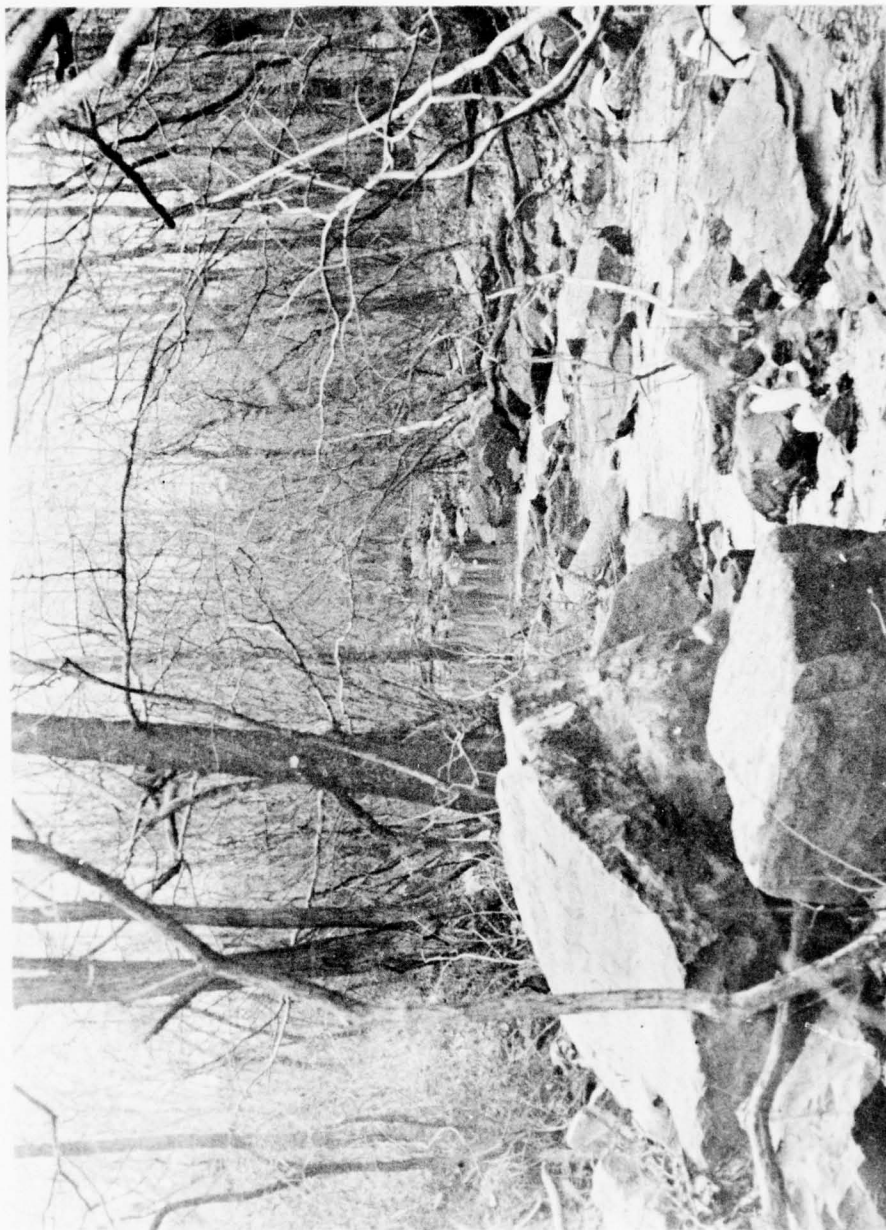
CARVIN COVE DAM - CARVIN CREEK
IMMEDIATELY DOWNSTREAM FROM DAM
